The City of Waxahachie Waxahachie Historic Resources Survey Update Final Report August 2004

HISTORIC RESOURCES SURVEY UPDATE – REPORT

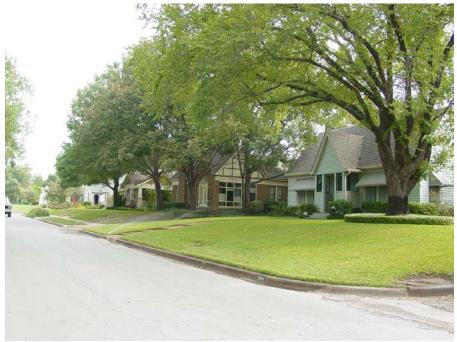
The Harbin/Kirven Street neighborhood contains a collection of one- and two-story residential properties that date from the early 1920s to the late 1940s. The neighborhood's earliest homes are bungalow-plan dwellings, some with Craftsman or Tudor Revival ornamentation, while its post-World War II historic-age resources are typically irregular-plan, Ranch- or Minimal Traditional-style dwellings. The neighborhood's houses sit on generous lots and share uniform setbacks and landscaping. In addition, there is little non-historic age infill or vacant lots in the neighborhood, and nearly all of the houses well maintained. Although similarities in style, setback, and scale create a good sense of cohesiveness within the neighborhood, many of its resources have undergone exterior modification after the historic period of significance. Common non-historic alterations include the application of synthetic exterior cladding, the replacement of original windows, and porch alterations. These modifications have led to an overall loss of historic character and architectural integrity within the neighborhood, rendering it ineligible for listing in the NRHP.

Streetscape. Harbin Street, showing porch (right) and window (left) alterations.

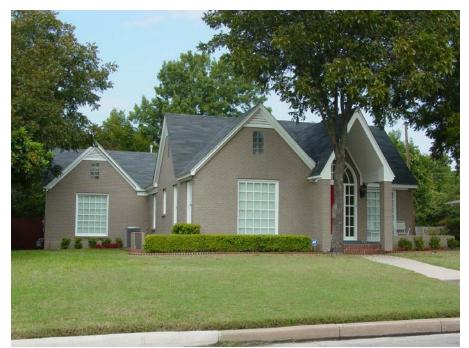
Dwelling, Harbin Street. Showing porch alteration.

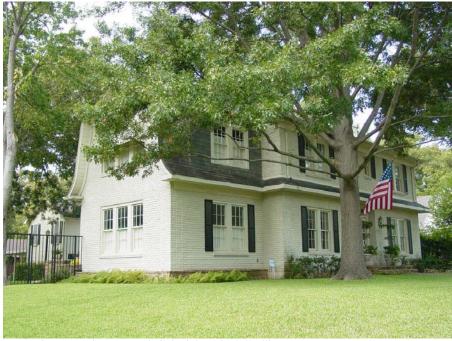
Sycamore Street is an east/west thoroughfare in the north-central portion of Waxahachie. The street, which is dominated by single-family, one- and two-story dwellings, contains a range of resources that date from the early 20th century to the late 20th century. Due primarily to its location off of Ferris Street/US 77, a main north/south commercial thoroughfare, the formerly solely residential street has undergone a small amount of commercial development. In addition, a number of vacant lots dot the eastern portion of the street. The most significant concentration of resources along Sycamore Street is situated within the 500-600 block, off Harbin and Kirven Streets. Within these blocks is a small number of Tudor Revival, Ranch, and Dutch Colonial Revival, early 1930s though late 1940s massed-plan, dwellings. As a whole, these dwellings are well maintained and have undergone little modification. Common changes to a number of dwellings along other parts of Sycamore Street include the replacement of original exterior materials and windows and additions affect the neighborhood's historic character. Furthermore, the presence of non-historic infill development and vacant lots has diminished the street's historic setting and its overall sense of cohesiveness. The survey update, therefore, recommends that Sycamore Street is not eligible for inclusion in the NRHP.

Sycamore Street. Dutch Colonial Revival dwelling.
